Aircraft Accident Investigation Interim Report

Crash Into The Sea After An In-Flight Fire

Asiana Airlines

B747-400F/HL7604

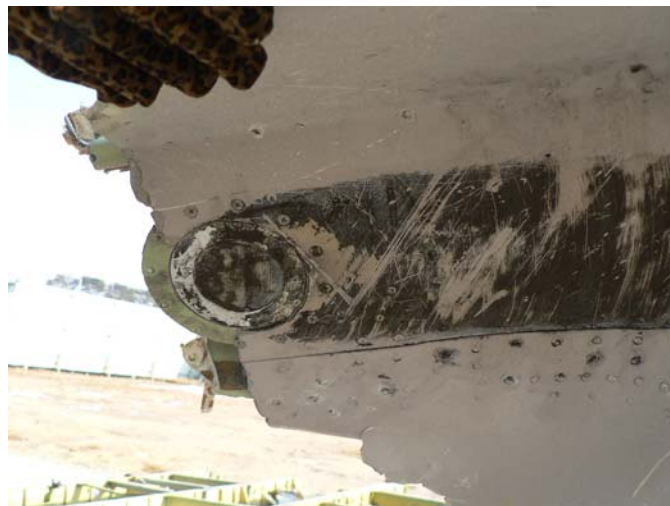
[Figure 19] Exterior Skin of the Cockpit Smoke Evacuation Shutter

As shown in [Figure 19], the cockpit smoke evacuation shutter was found closed, but a well defined soot trail was discovered on the exterior skin (tag # 1128). As a result of an examination, it was assumed that impact forces closed the shutter.

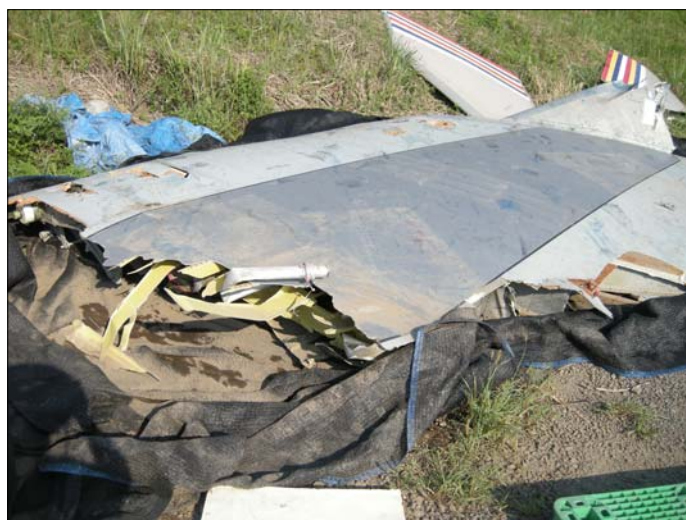
[Figure 20] Damage to the Right Wing

As shown in [Figure 20], the right wing tip was separated from the wing at wing station (hereinafter referred to as "WS") 1500. Blue dye splatters were found on the top surface of the wing, and multiple small electrical components with a diameter of 5 mm were imbedded in the composite wing upper surfaces.

The top and bottom surface of the wing contained multiple black waffle-like markings caused by collisions with electrical components containers as well as sporadic blue dye splatters.

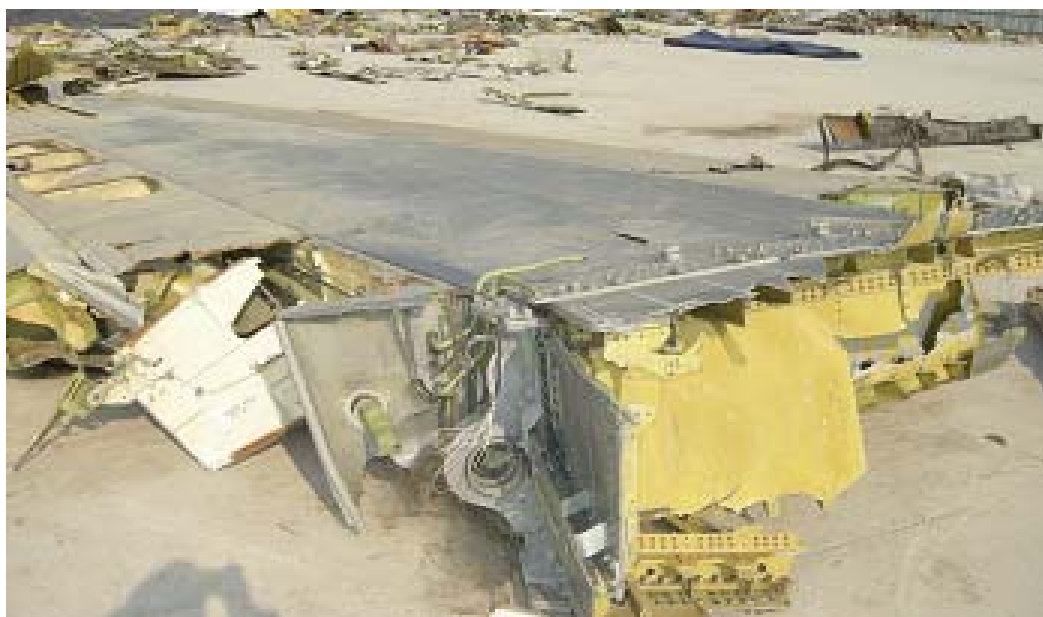
[Figure 21] Left Horizontal Stabilizer

As shown in [Figure 21], the left horizontal stabilizer was separated from the empennage. The remaining skin fragments along the upper and lower fracture areas were bent upwards.

The skin on the top side of the fracture zone contained areas of compressive buckling tearing.

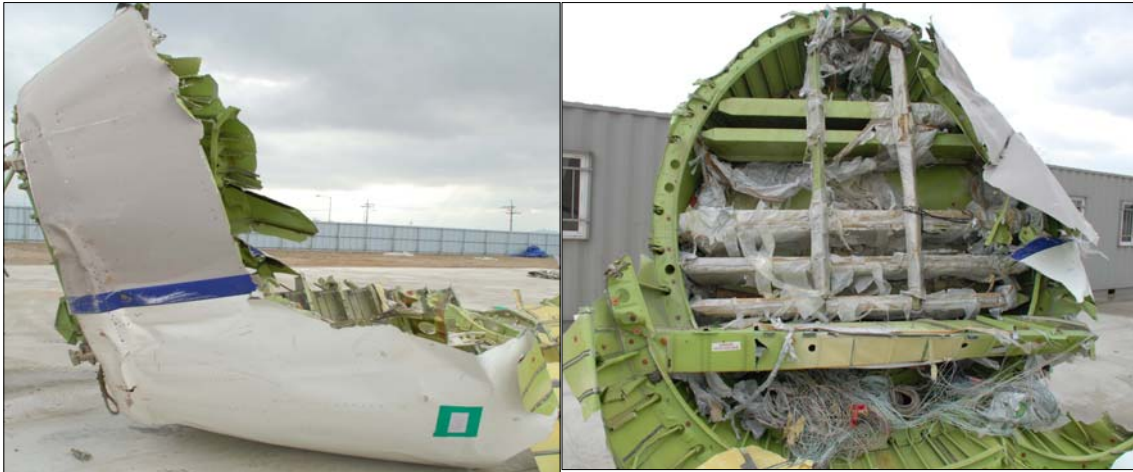
[Figure 22] Nose Cargo Door

As shown in [Figure 22], a forward section of the nose cargo door was separated from the fuselage at FS160/180, and the radome was missing.

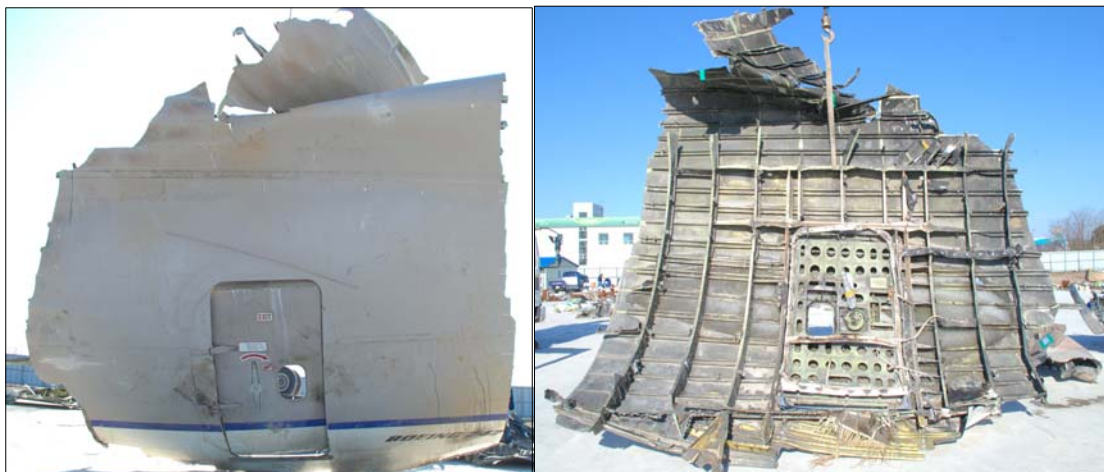
[Figure 23] Exterior and Interior Side of the L5 Door

As shown in [Figure 23], the flight data recorder rack mounted close to the L5 door was separated. The upper portion of the frame was thermally damaged, and the interior surface of the L5 door was heavily sooted.

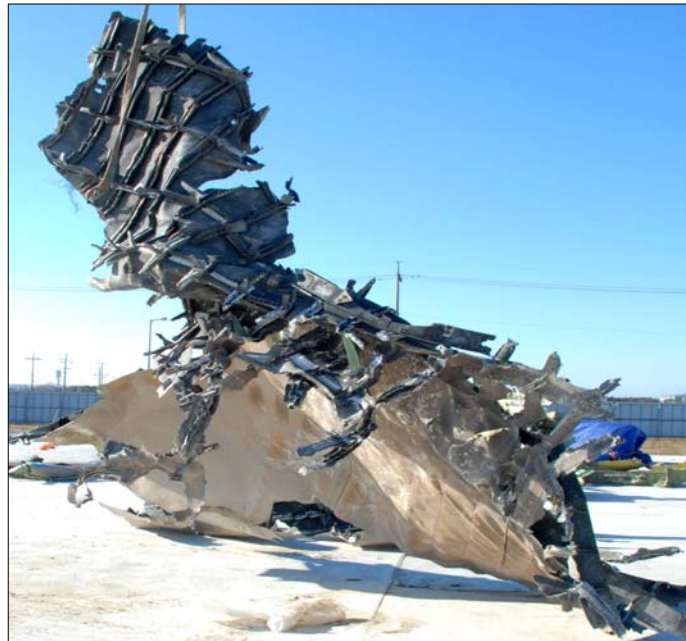
[Figure 24] Fire Damage to the Skin

the region between FS1740 and FS2360 contained thermal damage on the exterior skin as evidenced by discoloration of the exterior paint and internal metal structure. The recovered skin panel that extended from FS2180 to FS2360 (tag #511) was representative of this level of thermal damage and also contained areas where the skin had been burned through.

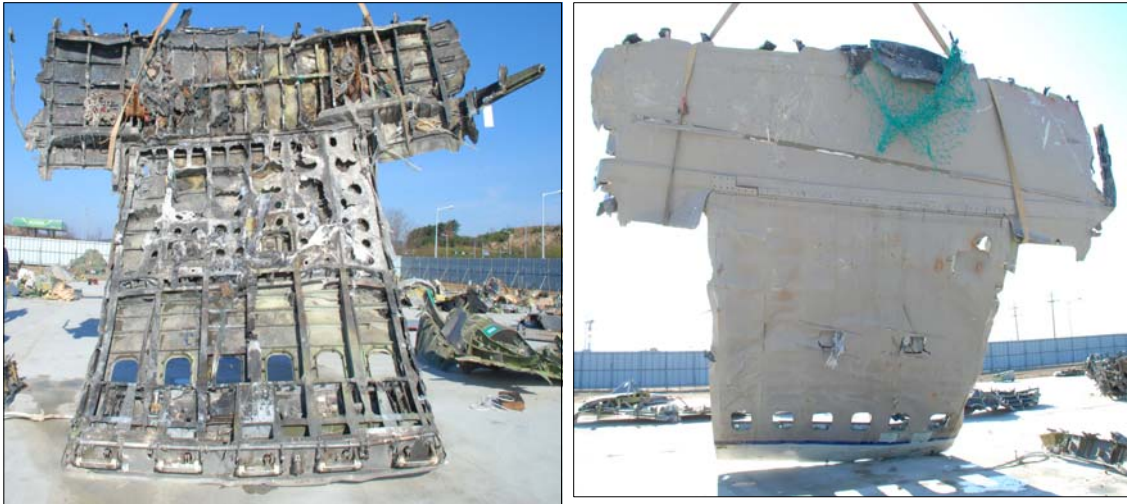
[Figure 25] Interior and Exterior Side of the Main Deck Cargo Door

As shown in [Figure 25], the inner insulation materials of the main deck cargo door aft of the left fuselage was burned, and some cargo items melt and charred stuck to the interior surface of the wreckage. The frame and cargo items were melt and stuck to the upper side of the door hinge.

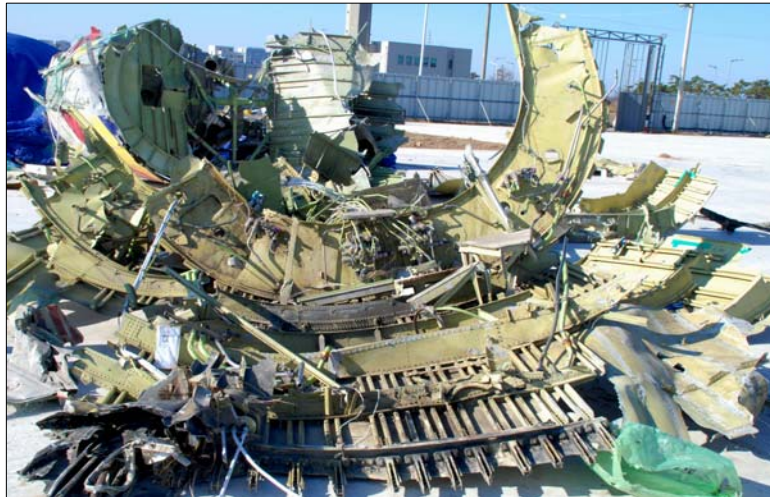
[Figure 26] Damage to the Section 48 of the Aft Fuselage

As shown in [Figure 26], the section 48 of the aft fuselage contained no internal sooting or fire damage but did have external soot accumulation on the underside of the left and right skin panels. Most of the damage appeared to have been caused by impact forces during the crash into the sea.

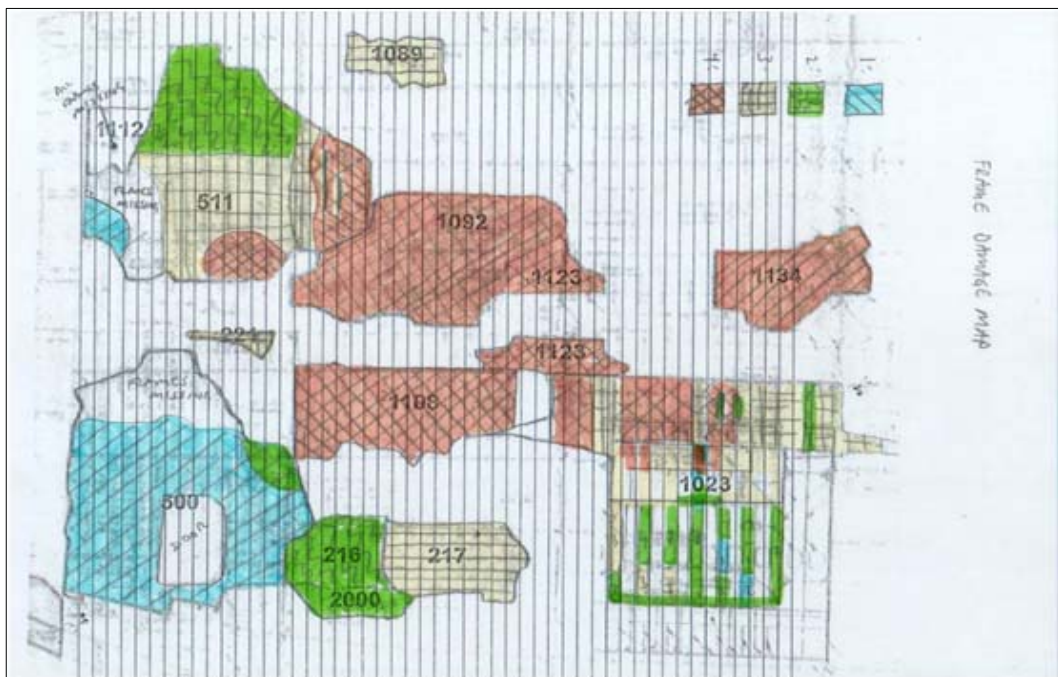
[Figure 28] Airframe Thermal Damage Map

The wreckage from this area have the most fire damage of all the wreckage collected to date. Detailed thermal damage maps were generated for these portions of the aircraft. These portions included tag numbers 1089, 1112, 511, 1092, 1123, 1134, 221, 1108, 500, 216, 217, 2000, and 1023. They were mostly between the aft main deck cargo door and the L5 door as shown in [Figure 28]. This area can be characterized overall as having been exposed to the highest temperatures as evidenced by severe thermal damage on the interior structure and discoloration of the paint on the exterior of the aircraft's skin.

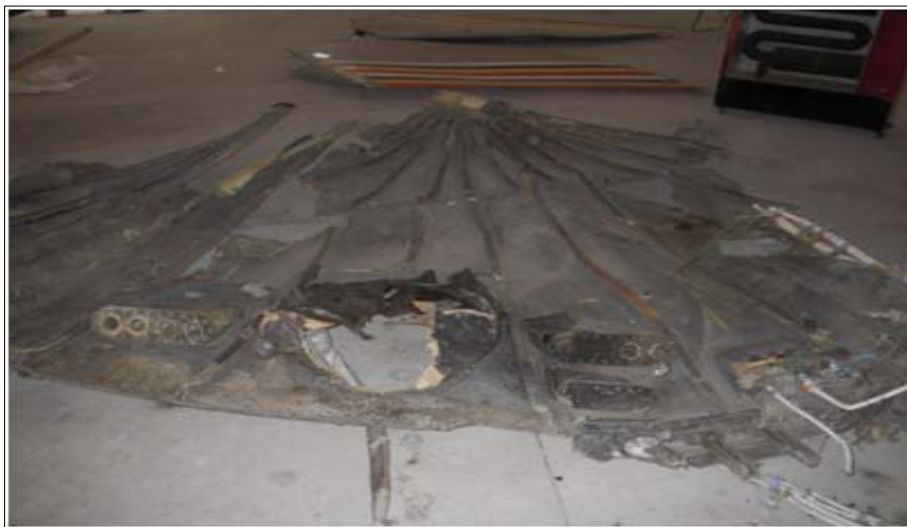
[Figure 29] Aft Pressure Bulkhead Showing Side Facing Main Cargo Deck

The aft pressure bulkhead was partially recovered in multiple pieces. They had sustained thermal damage originating on the side facing the interior of the main cargo deck.

Portions of the aft pressure bulkhead showing the side facing the main cargo deck is shown in [Figure 29]. As shown in [Figure 30], portions of the wreckage aft of the pressure bulkhead did not have evidence of fire damage.

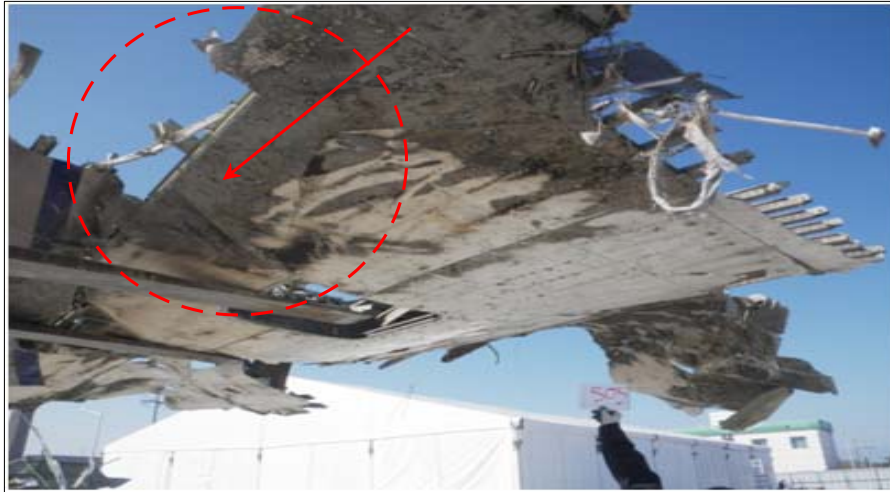
[Figure 31] Soot Trails from Outflow Valves

As shown in [Figure 31], on the exterior of the skin panels on the right and left side of the wreckage aft of the pressure bulkhead were soot trails (marked as arrow) caused by smoke exiting the outflow valves.

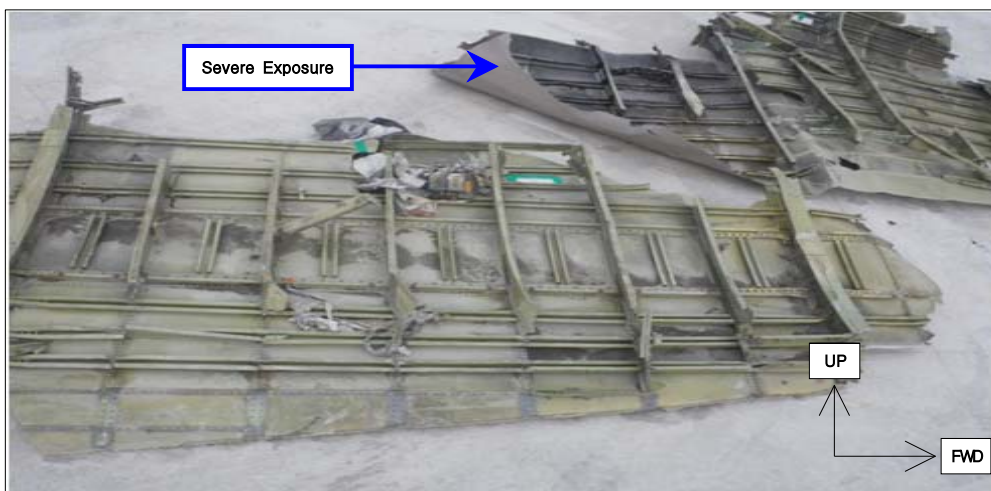
[Figure 32] Wreckage forward of FS1700

As shown in [Figure 32], portions of the wreckage forward of FS1700 generally had fire damage consisting of sooting with areas of more severe damage along the upper areas of the aircraft's crown²⁷). Evidence of sooting was found all the way forward in the main cargo deck on the bottom face of the ceiling liners under the flight deck.

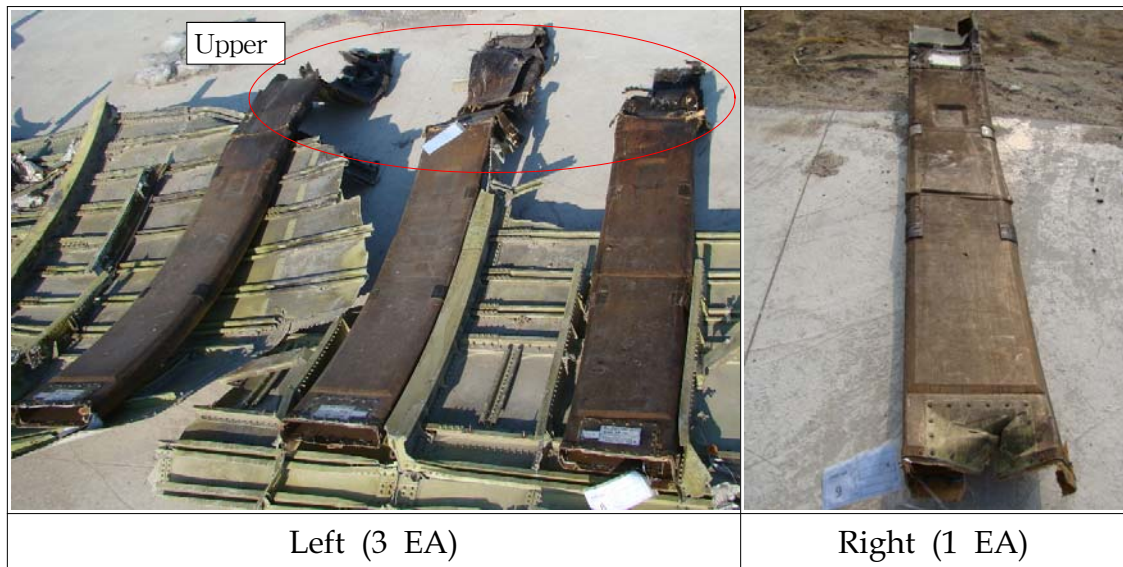
[Figure 35] Riser Ducts

Portions of four out of the six riser ducts²⁸⁾ on the aircraft were examined. As shown in [Figure 35], all of these ducts had sustained fire damage which was consistently more severe along the upper portions and tapered off towards the bottom.

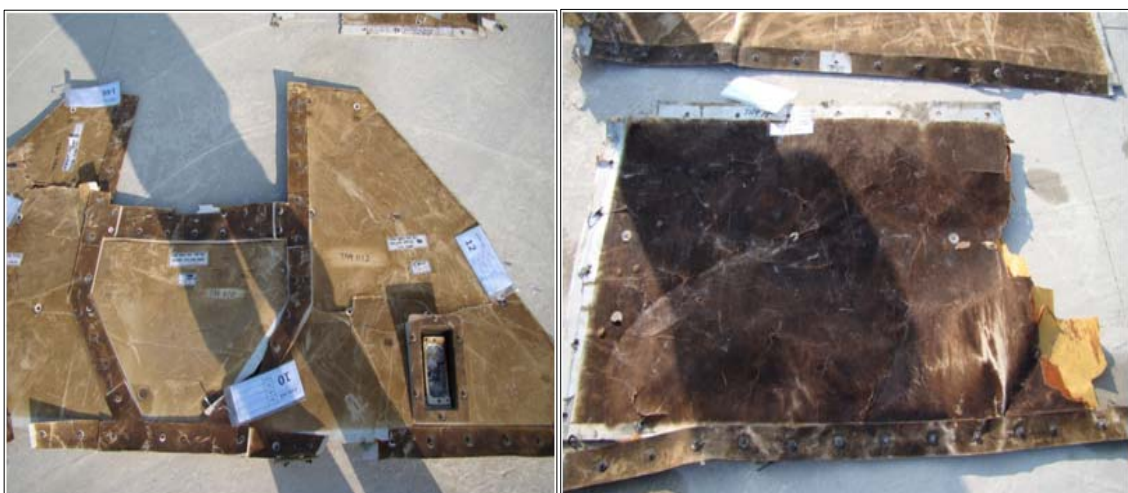
[Figure 36] Liners from Vicinity of and Aft of FS360

Portions of the ceiling panels belonging to the area under the flight deck were examined. As shown in [Figure 36], the forward most ones from the vicinity of FS360 had a layer of soot adhering to the surface. Ceiling liners aft of FS360 were also sooted and had a darker appearance.

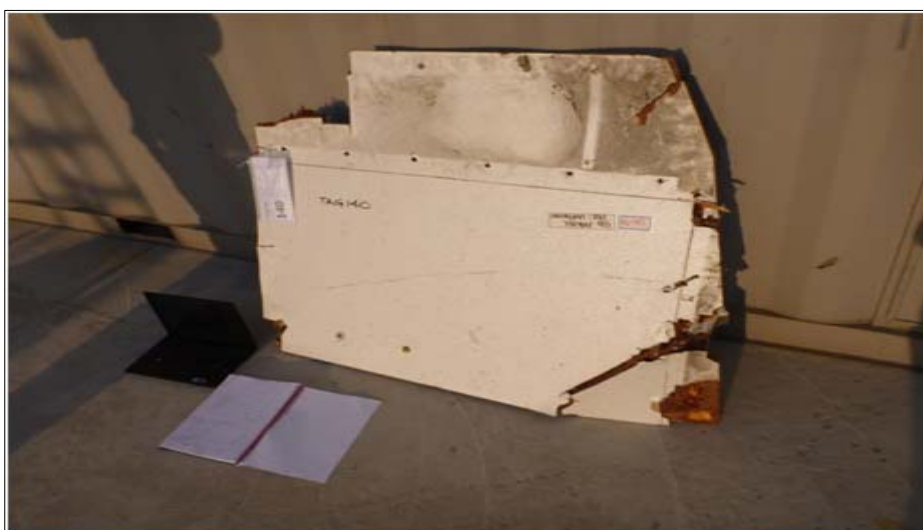
[Figure 37] Upper Deck Interior Panel with Area of Sooting

As shown in [Figure 37], a panel from the interior of the upper deck area was found to have an area exhibiting soot accumulation. The panel is part of the lavatory module wall where the cabin attendant panel and emergency equipment is installed.
